WADC TECHNICAL REPORT 55-56  
PART II

**PROTECTIVE SHOT PEENING OF PROPELLERS**

**Part II. Fatigue Tests**

*LESSELLS AND ASSOCIATES, INC.*

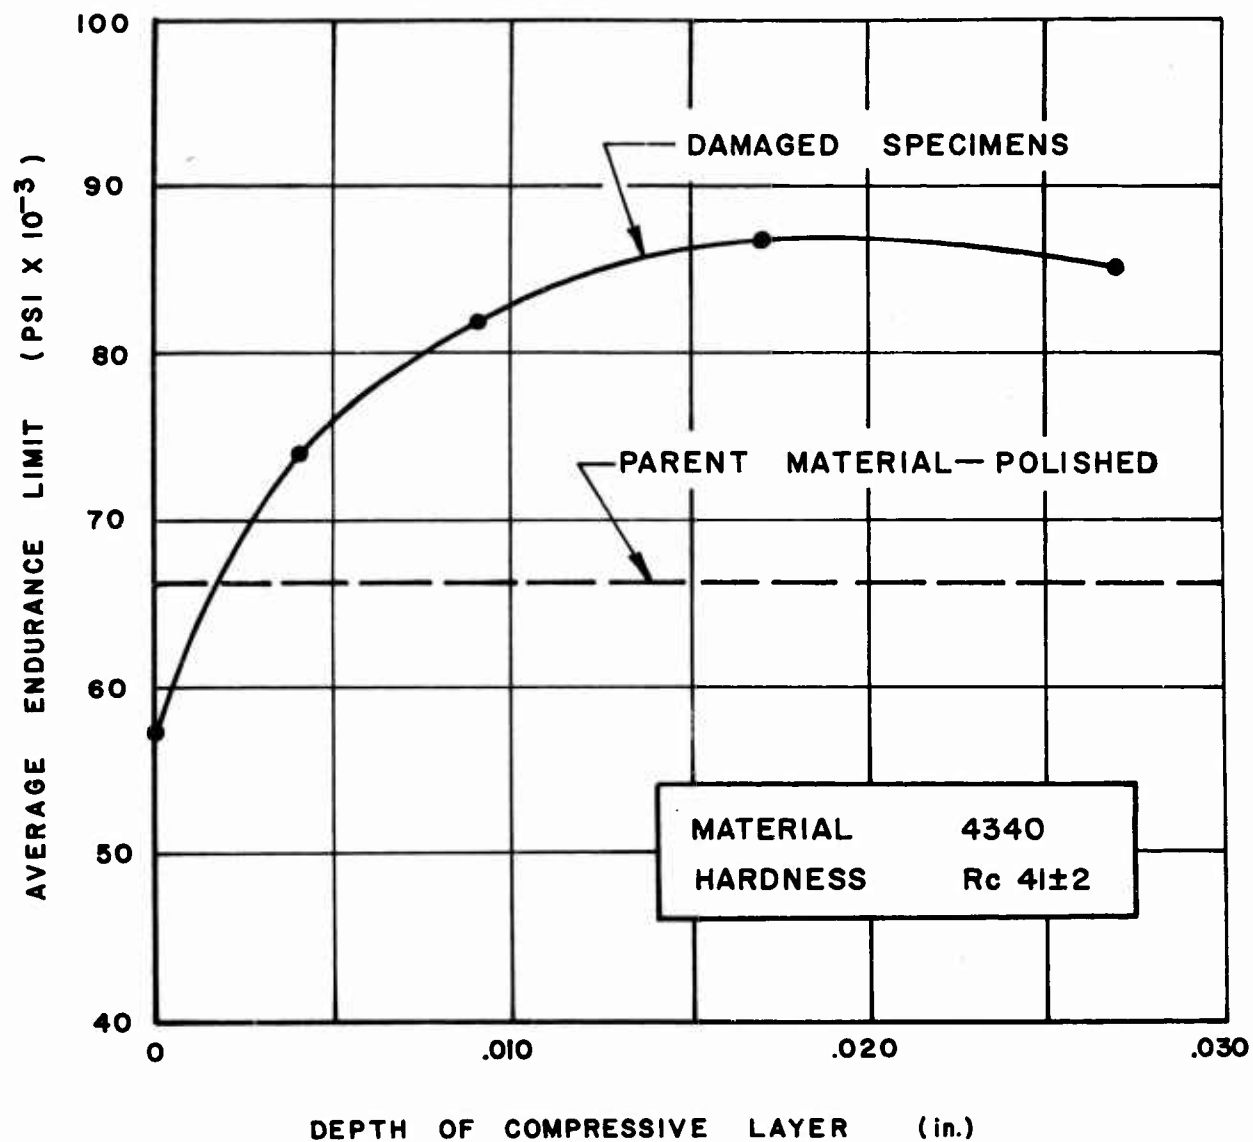
Figure 15 is a summary of results for the 190,000 psi steel. From this plot it can be seen that nearly a 50% improvement over the unpeened damaged condition arises from the shot peening. Under the conditions of damage attained in these tests there appears to be an optimum depth of compression of about 0.015 in., beyond which the strength is slightly reduced from maximum. This reduction is probably a result of surface roughness caused by extremely heavy shot peening. Even at the lightest peening treatment, an improvement of about 30% was obtained. This light treatment had the appearance of a burnished surface, with only very slight surface roughness.

FIGURE 15. SUMMARY OF RESULTS — Rc 41

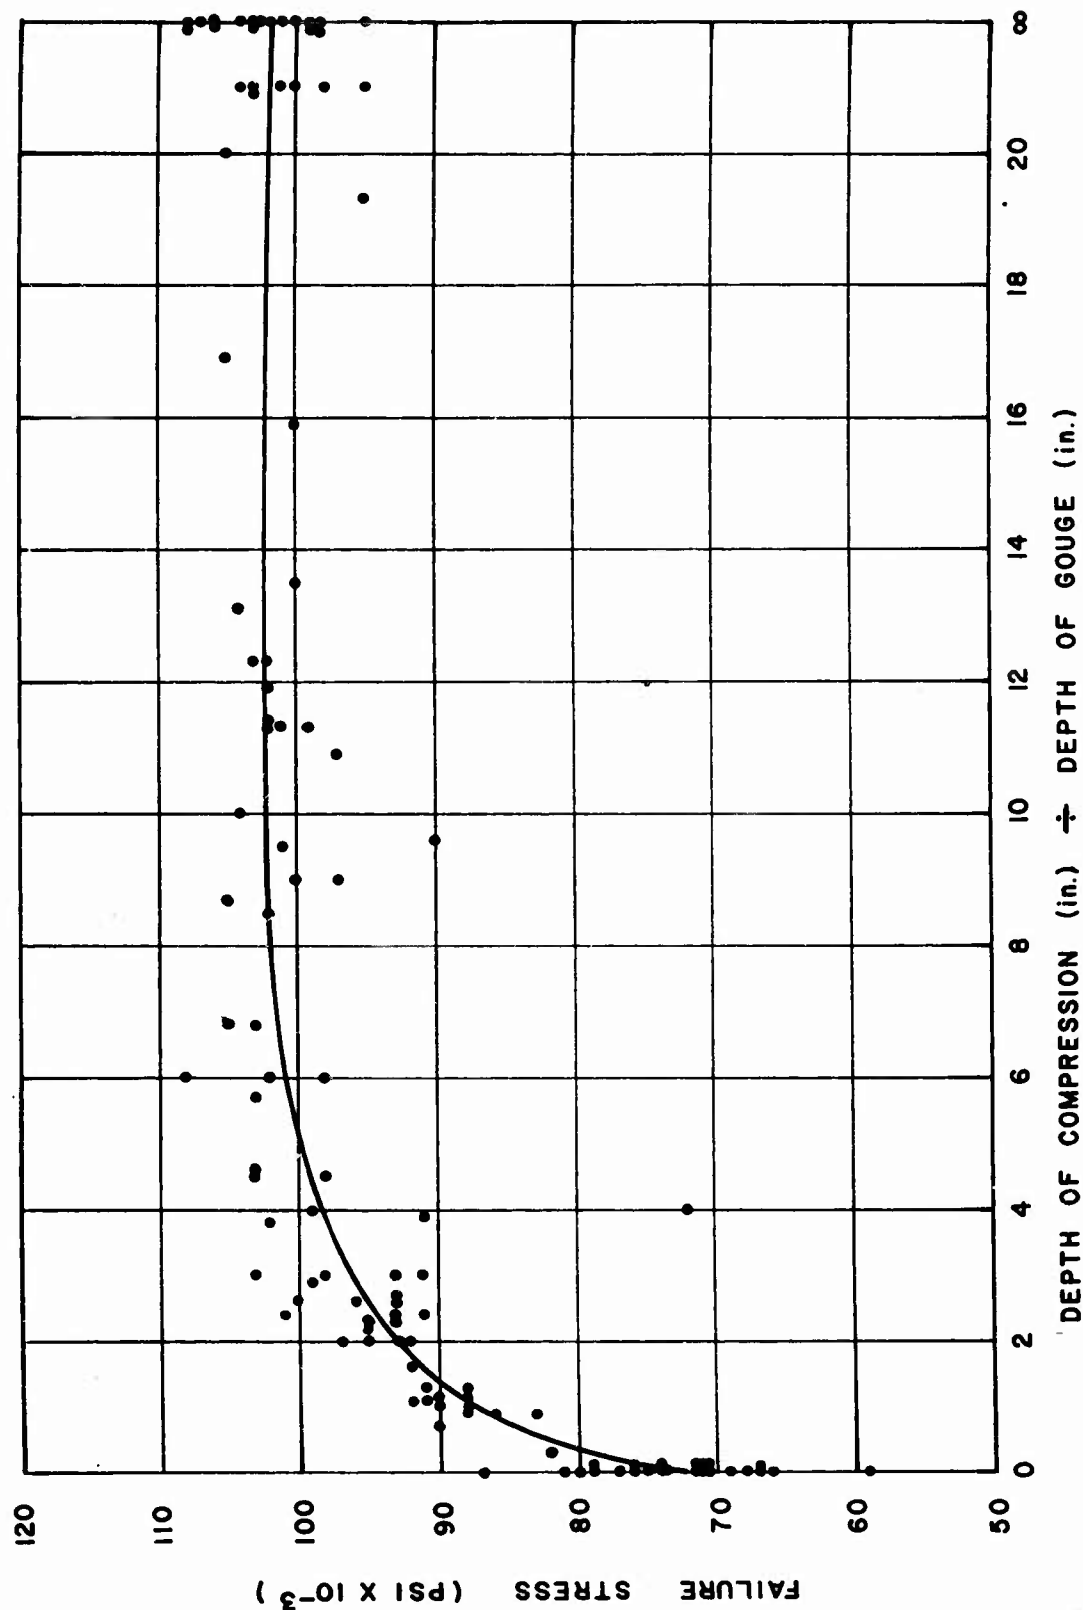
In order to indicate the benefits of peening on a dimensionless basis, Figure 16 is included. In this figure the parameter of depth of compression over depth of damage is used. It appears that a value of five for this ratio represents the maximum attainable improvement over the unpeened case. However, even a ratio of two represents a considerable improvement.

FIGURE 16. ENDURANCE LIMIT Vs. DEPTH RATIO OF Rc 41 DAMAGED SPECIMENS

An attempt to analyze the nature of the simulated damage and its relation to fatigue failure was unsuccessful, except for the factor of gouge depth. Shape and form of the individual damage loci were so widely variant (as they are in service propellers) as to make it impossible to group them into patterns for analysis. In general the deeper gouges resulted in lowest endurance limits (as can be seen in Figure 16), although there were many exceptions.

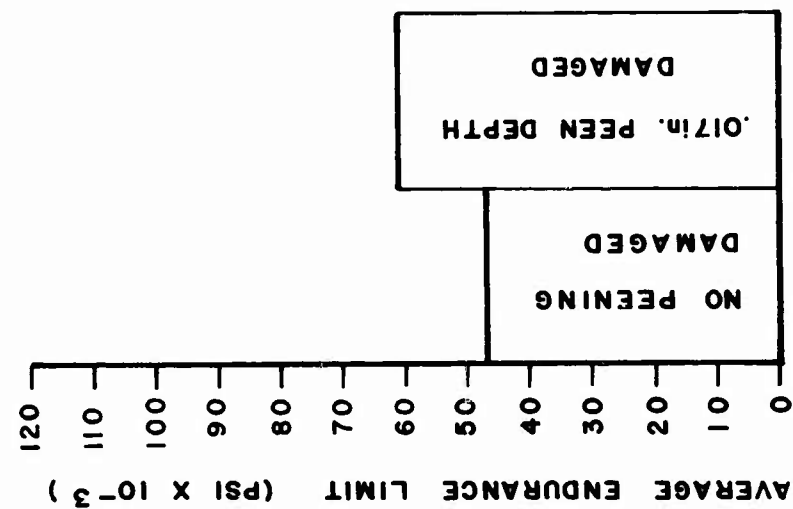
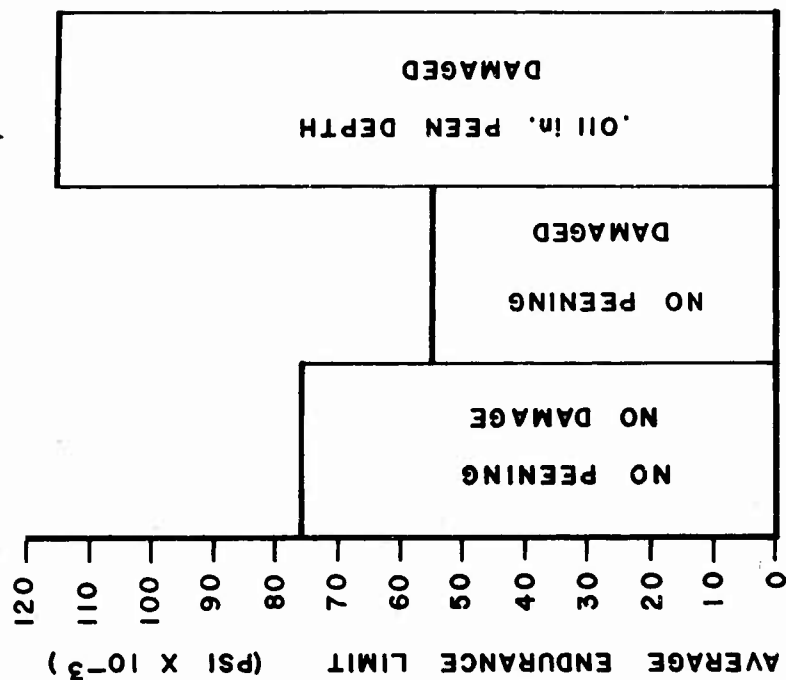
Figures 17 and 18 show the degree of improvement for the 130,000 psi and 260,000 psi steel, respectively. In selecting the single depth of compression to be used in the 130,000 psi steel, and similarly in the 260,000 psi steel, an attempt was made to establish a ratio of five for depth of compression over depth of damage. Although the depth of compression could be controlled quite accurately, it was necessary to extrapolate depth of damage from data on the 190,000 psi specimens. This depth was estimated on the basis of the relative depths of a spherical hardness indenter in the different materials. Actual measurement of damage depth was somewhat inaccurate in the case of the very hard specimens, since the depths were very small. Measurement was also inaccurate in the cases of very heavy peening of the medium strength steel, since the rough peened surface offered a poor reference plane for the fairly shallow depths of damage. Figure 19 shows the relation of endurance limit to depth ratio for the 190,000 psi steel. Although the number of test points is limited, it appears that a depth ratio of about five represents the maximum improvement.

It was not possible to analyze the depth ratio for the 260,000 psi steel as the damage depths were extremely small and only ten peened and damaged specimens were tested. Nevertheless, this material, in the peened and damaged condition, showed about a 50% increase in endurance limit over the parent material and about a 110% increase over the unpeened damaged condition, as depicted in Figure 18.

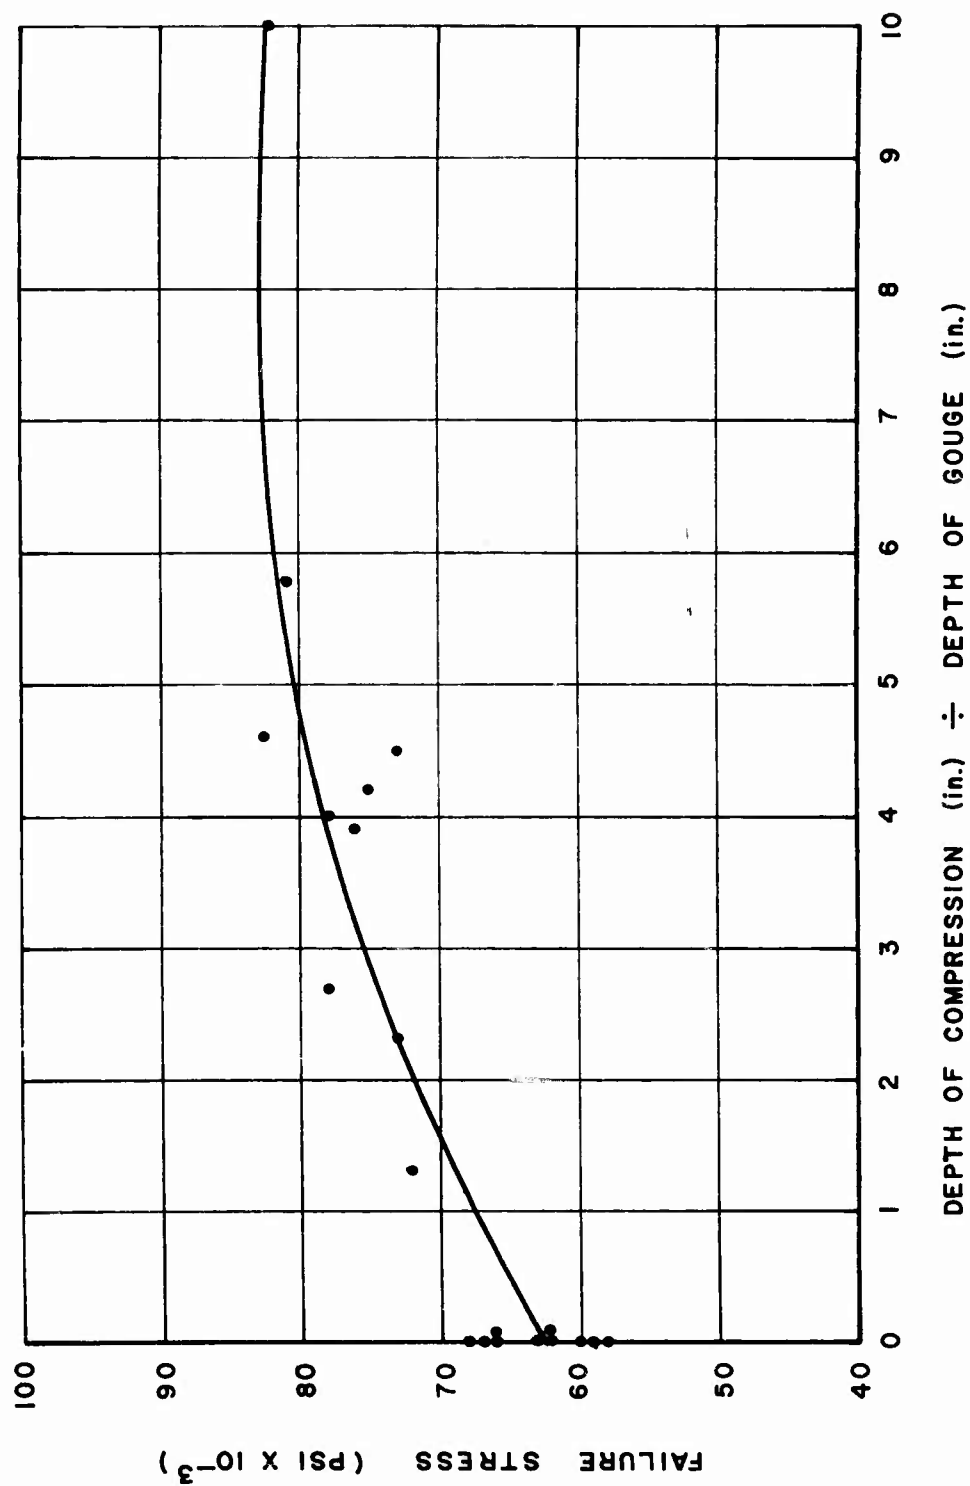
FIGURE 19. ENDURANCE LIMIT VS. DEPTH RATIO OF Rc 31 DAMAGED SPECIMENS

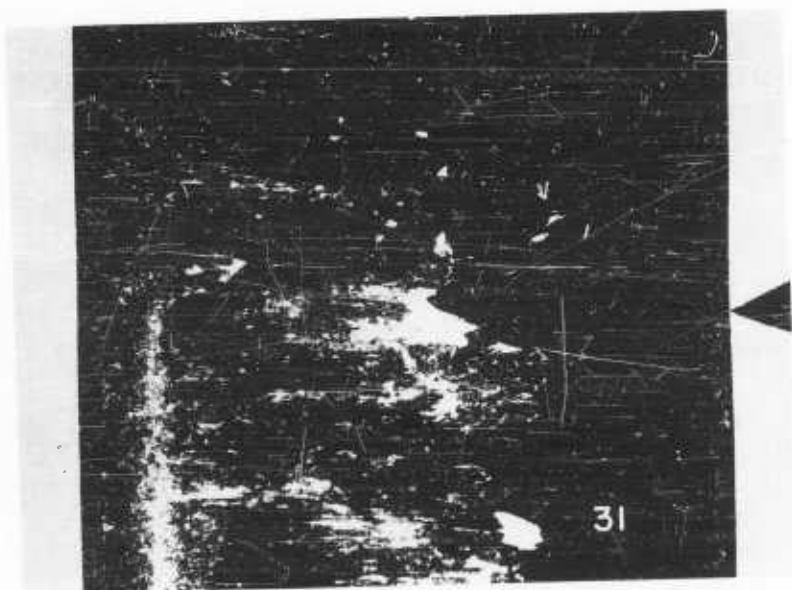
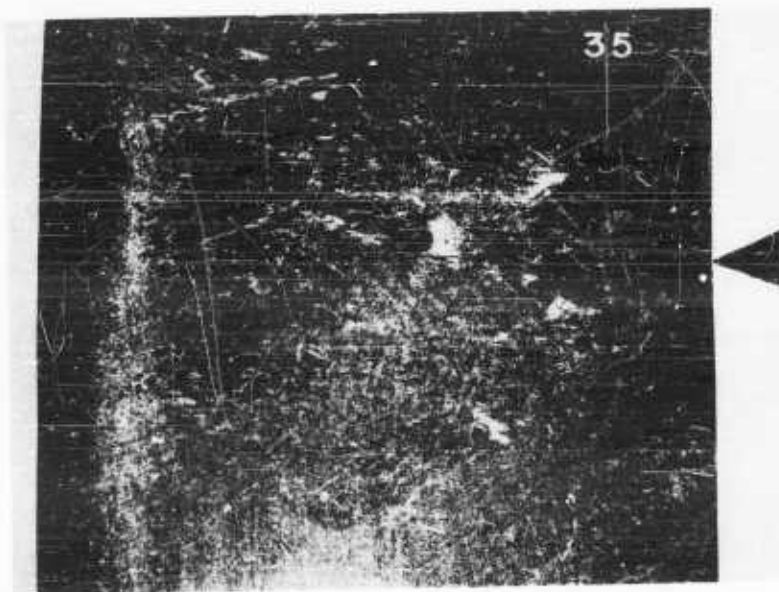
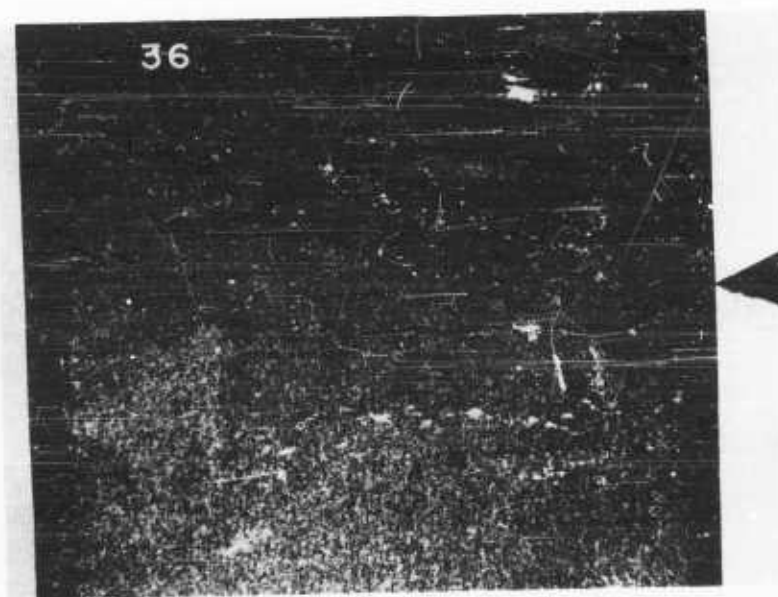
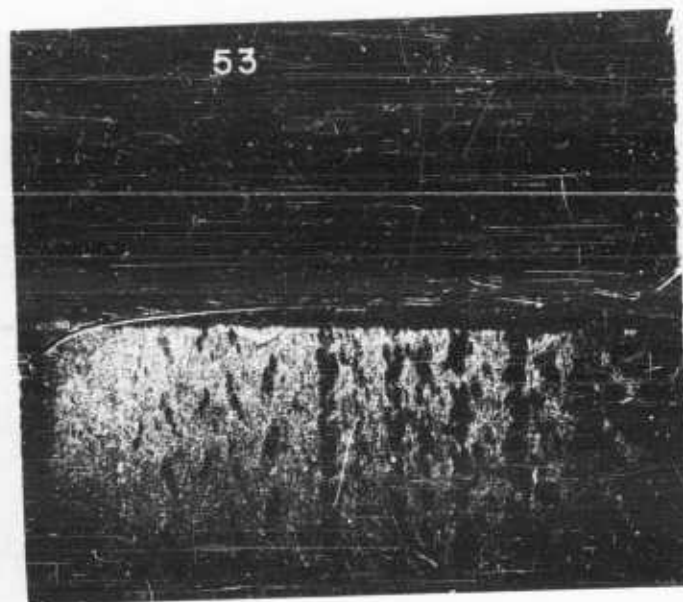
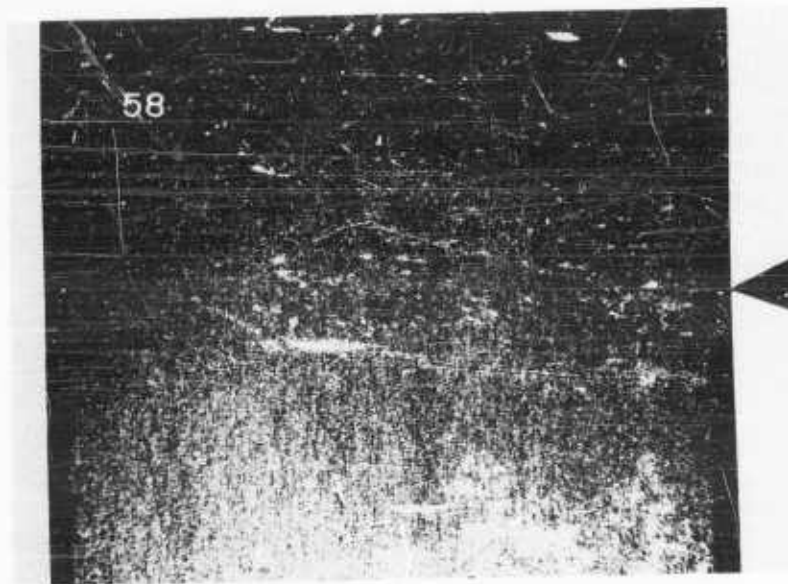
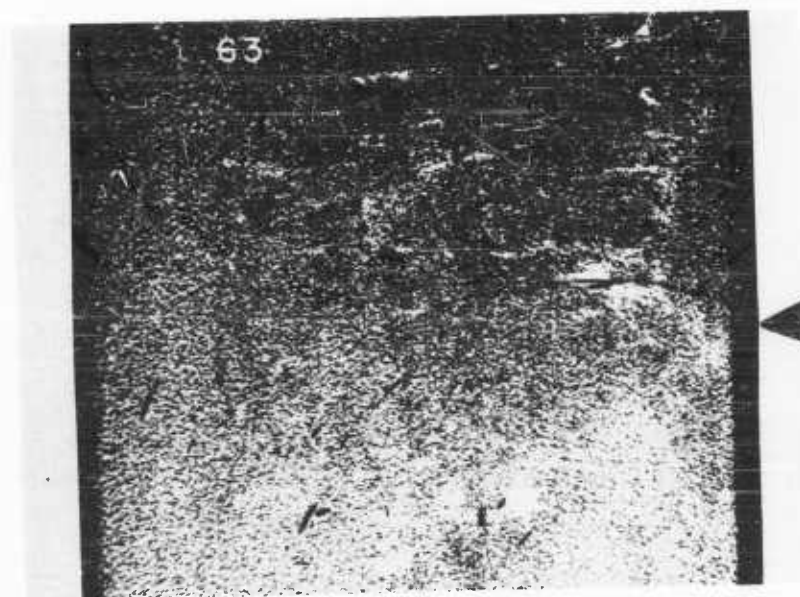
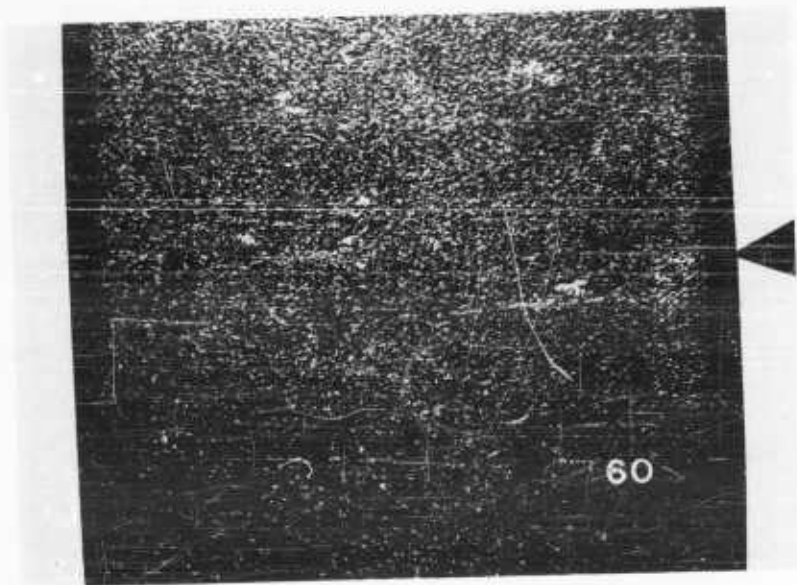
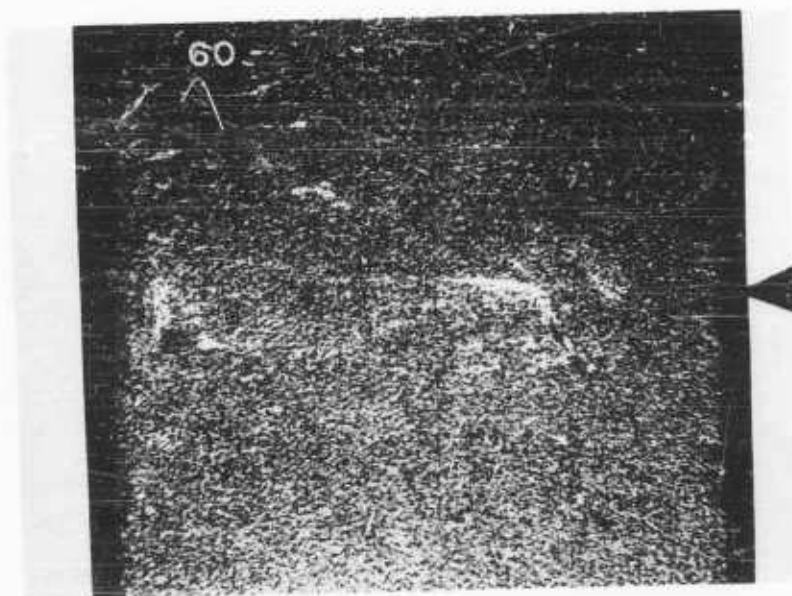
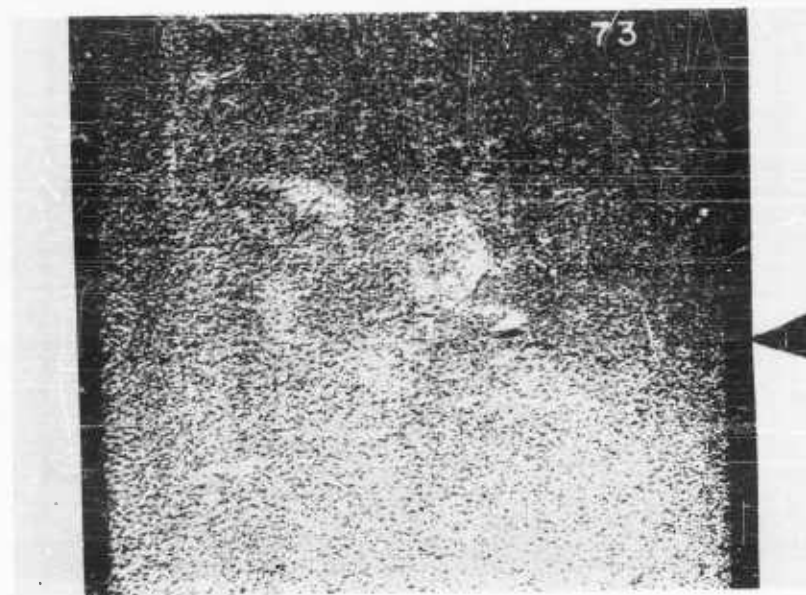
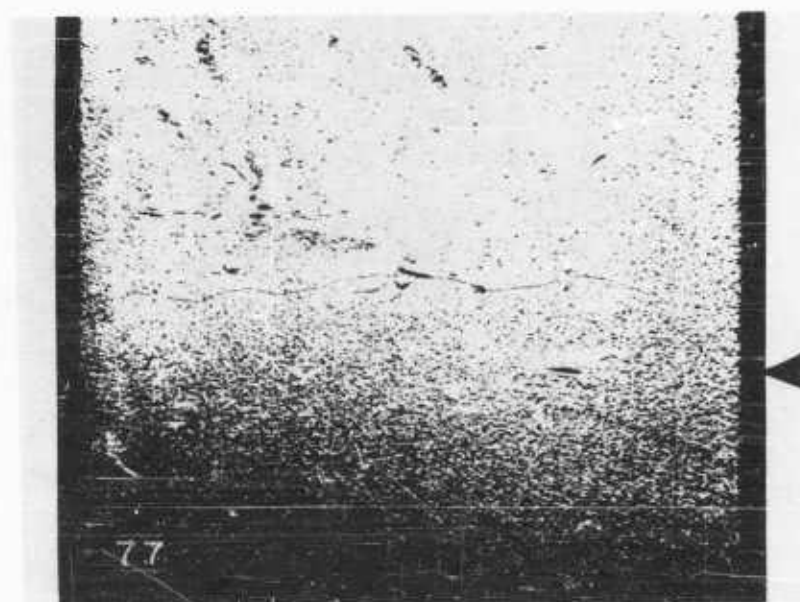
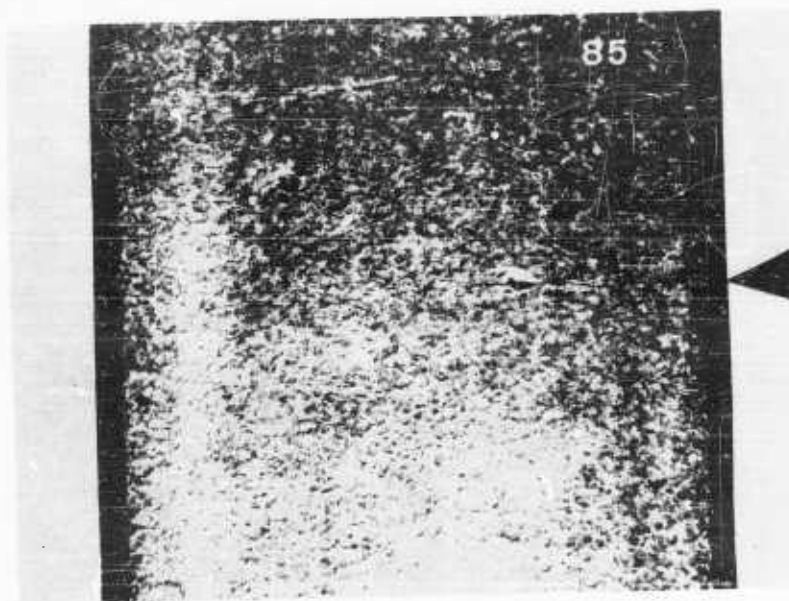
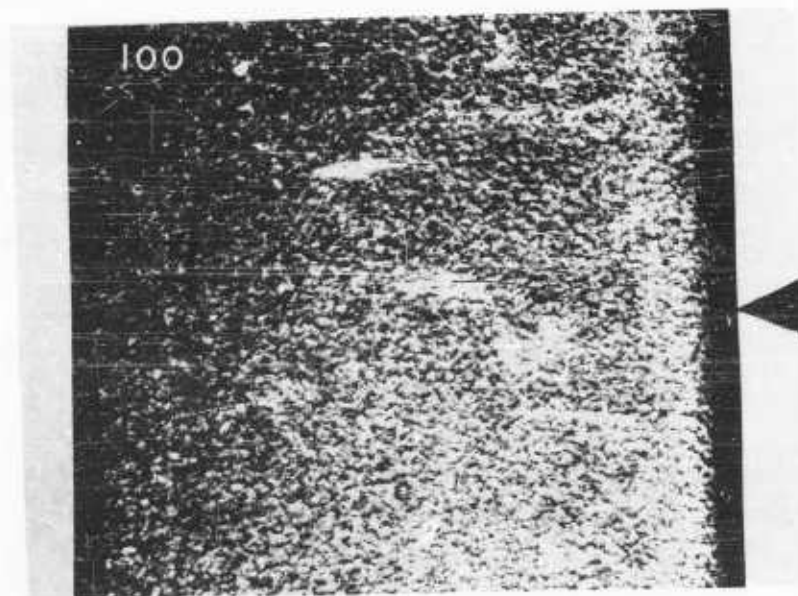
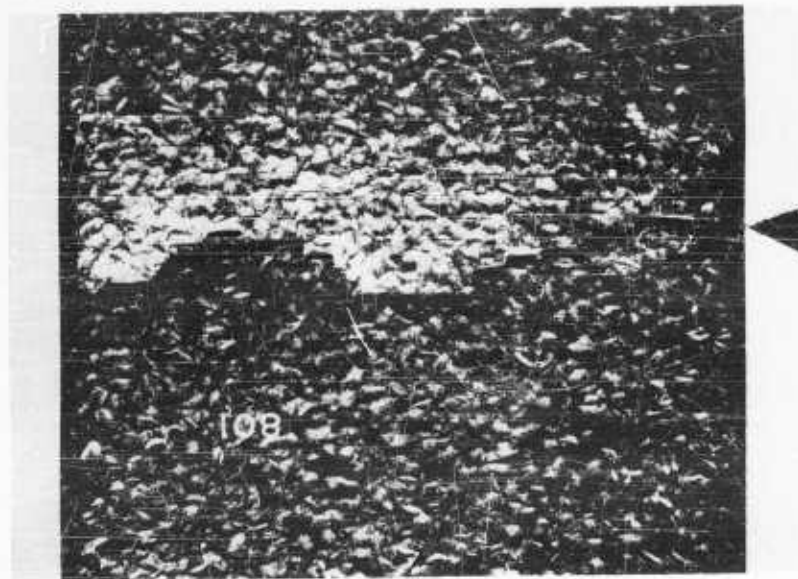
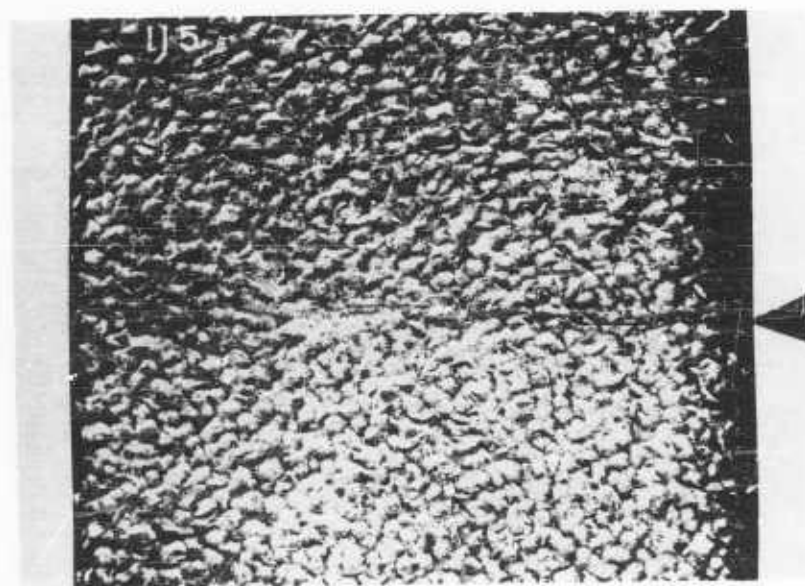
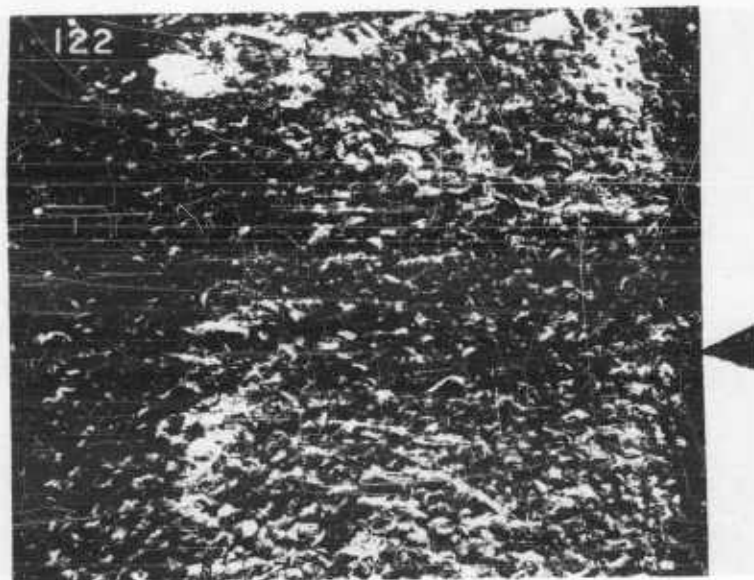
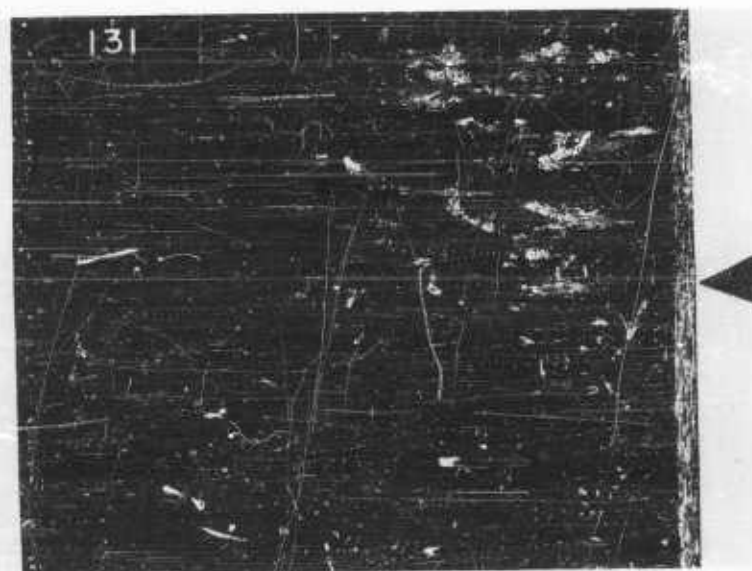
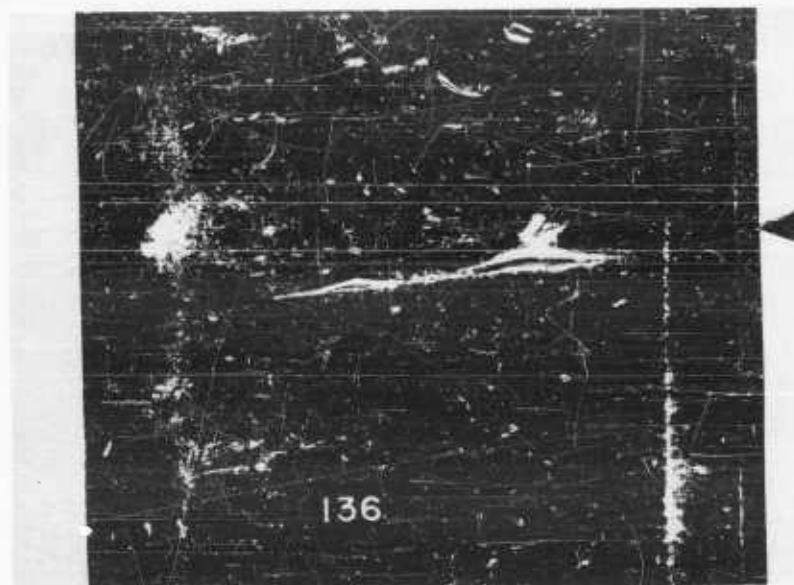
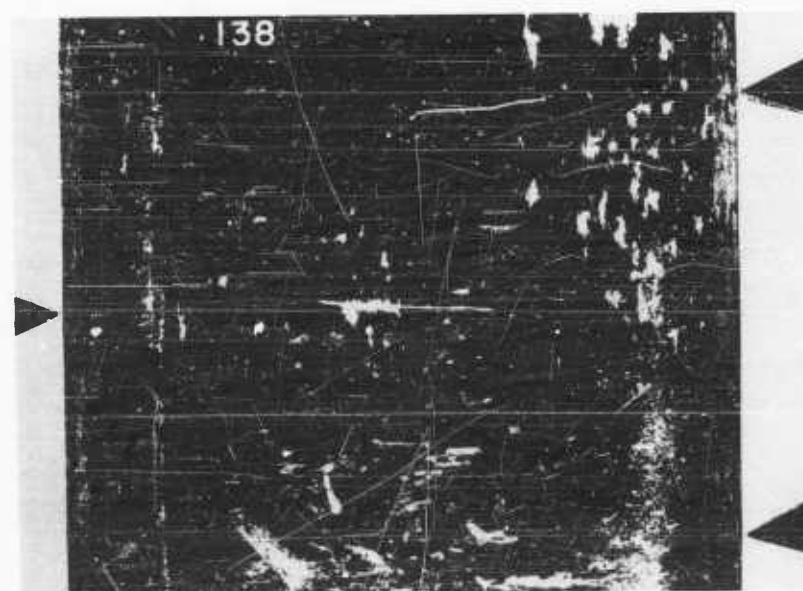
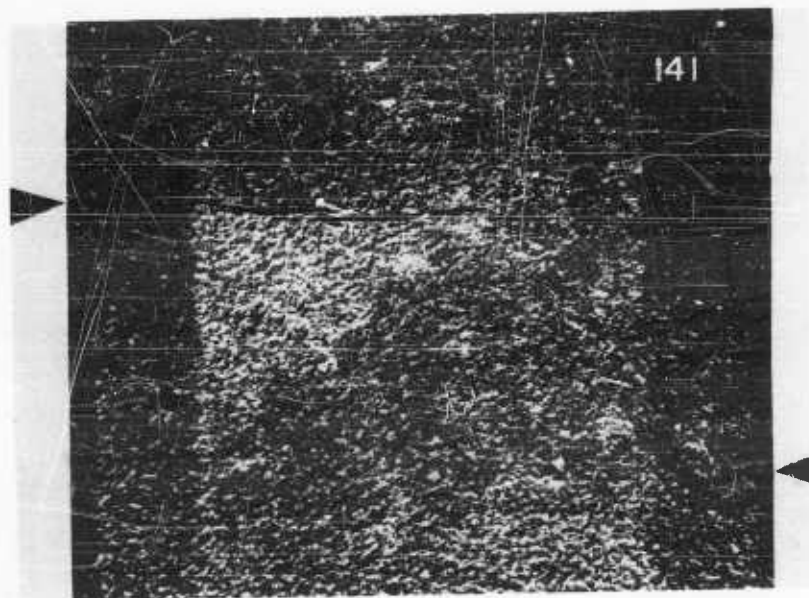
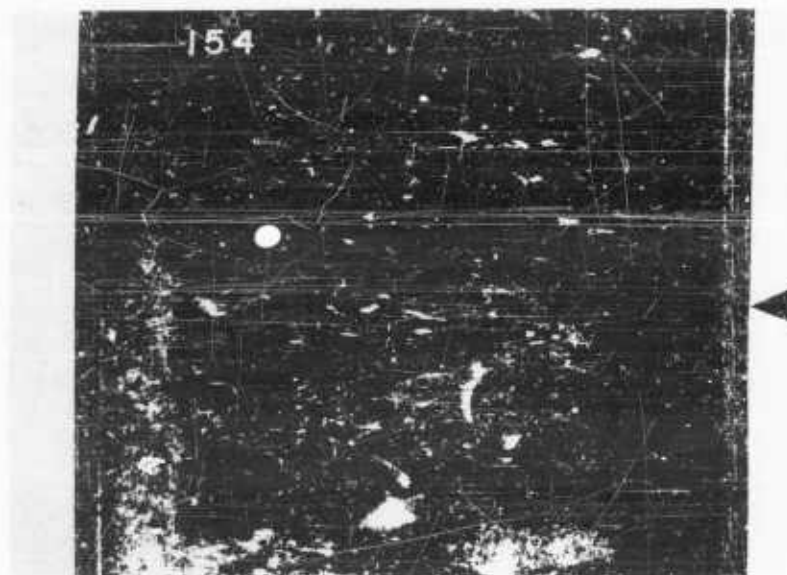
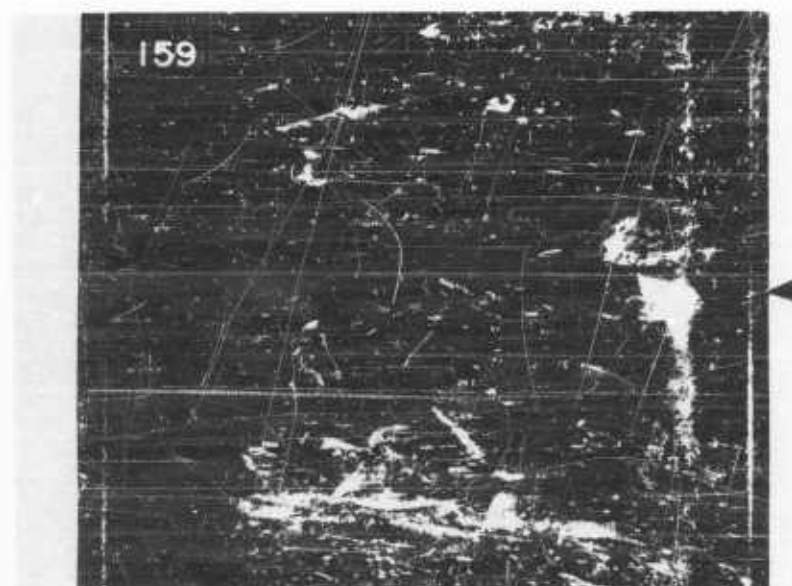
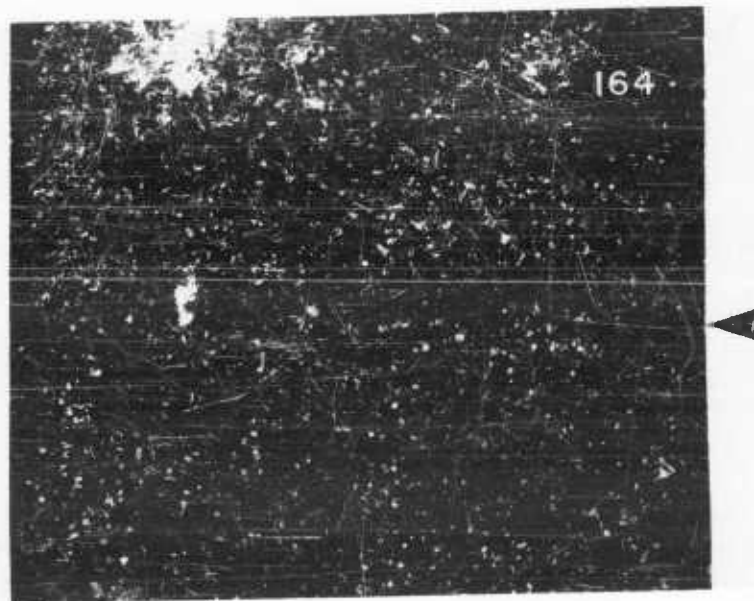
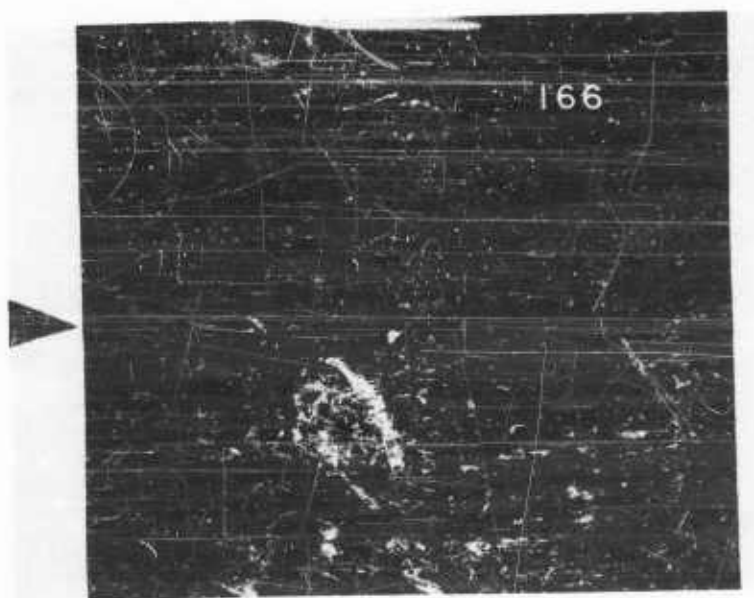
Figures 20 through 45 are photographs of failed test specimens, showing several typical failures. Many of the cracks run to at least one edge of the specimen. This is usually a result of crack growth from a nucleus nearer the midpoint of the specimen, although some cracks did start at the chamfered edge. The stress at this edge is calculated to be less than one percent greater (due to anticlastic curvature) than the stress along the center line of the bar. In cases where there was doubt as to the origin of failure, the bars were broken in two and examined for beach marks pointing to the origin. In a few cases, two or more cracks were formed.

Figures 20 through 45 are included to show the general appearance of the shot peened surfaces, the artificial damage and the failures. The triangular pointer at the side of each photograph indicates the location of the failure. In case of multiple failures, multiple photographs are included. Photographs are approximately 4X magnification.
